The wood species that used in the earthquake-resistant traditional timber structures in Istanbul

Assist. Prof. Dr. HÜLYA DIŞKAYA

Mimar Sinan Fine Arts University, Istanbul

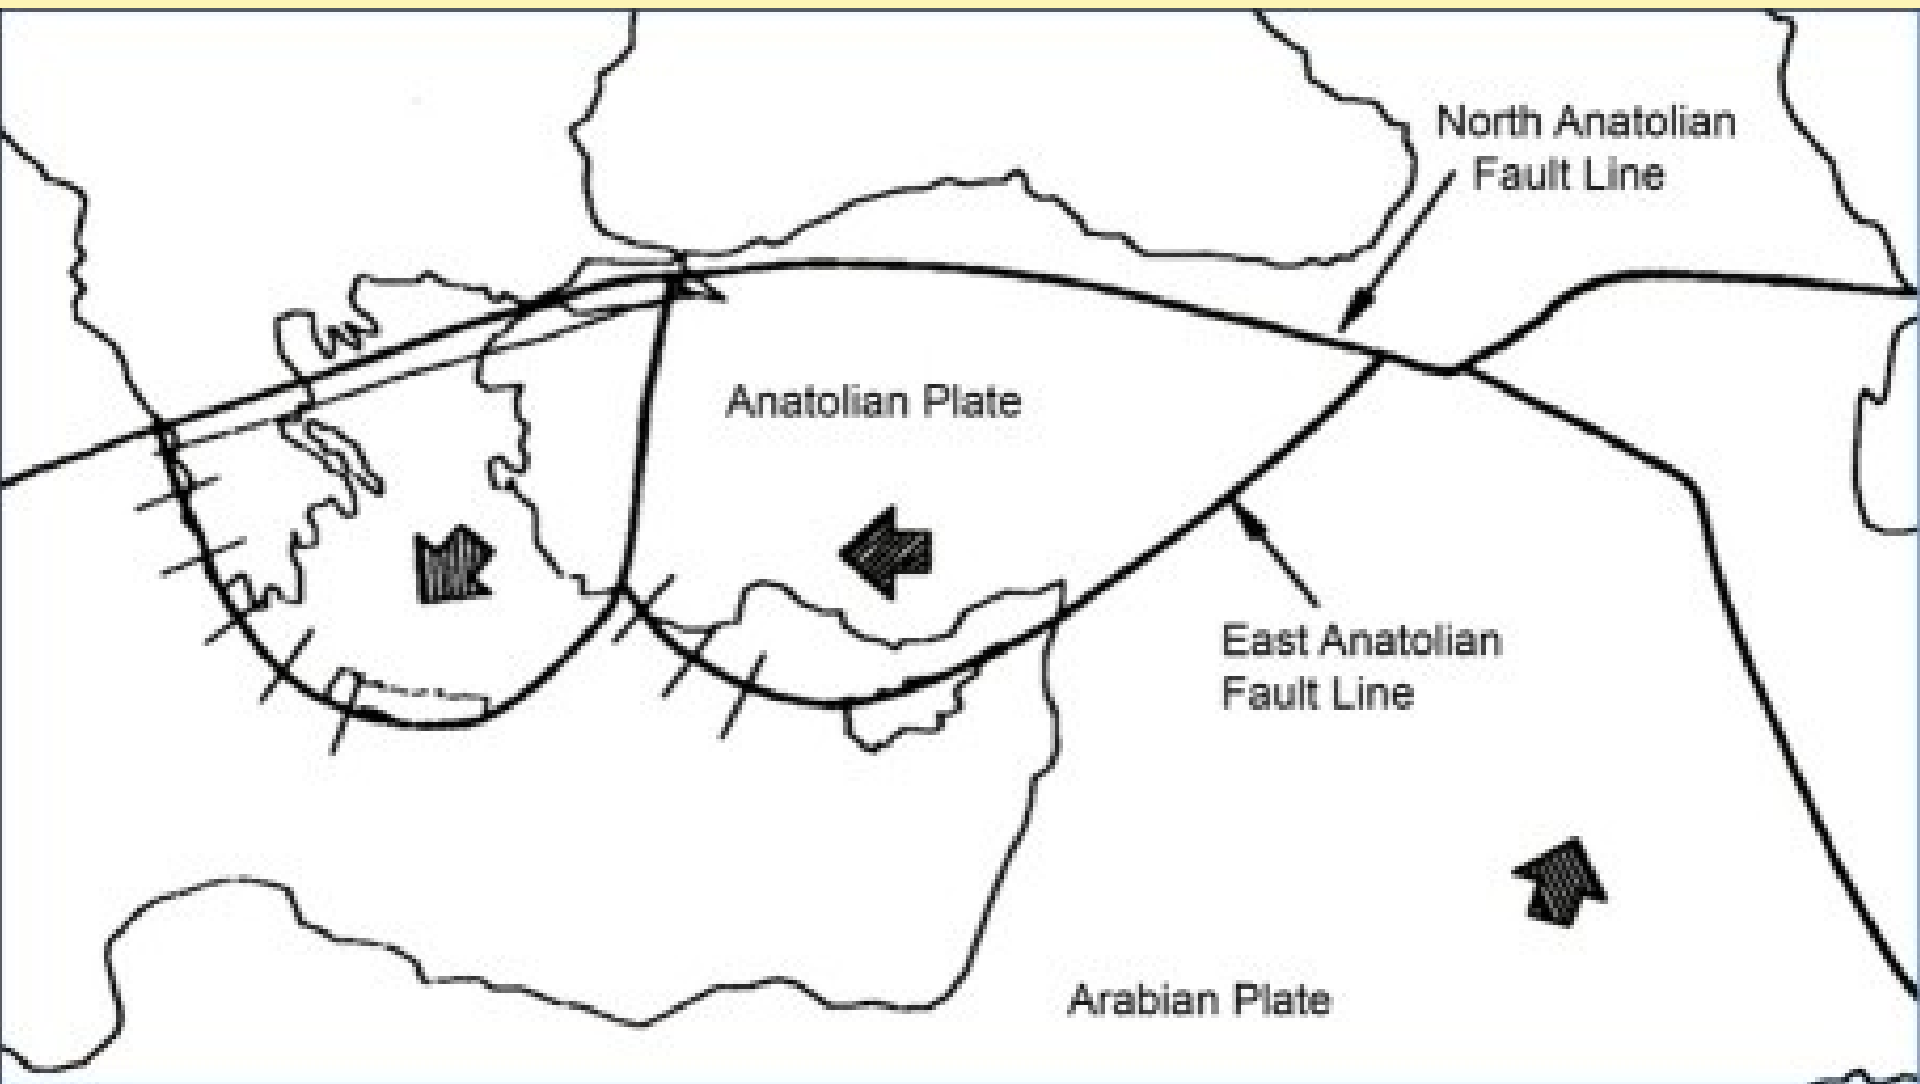
Map showing the North Anatolian Fault Line

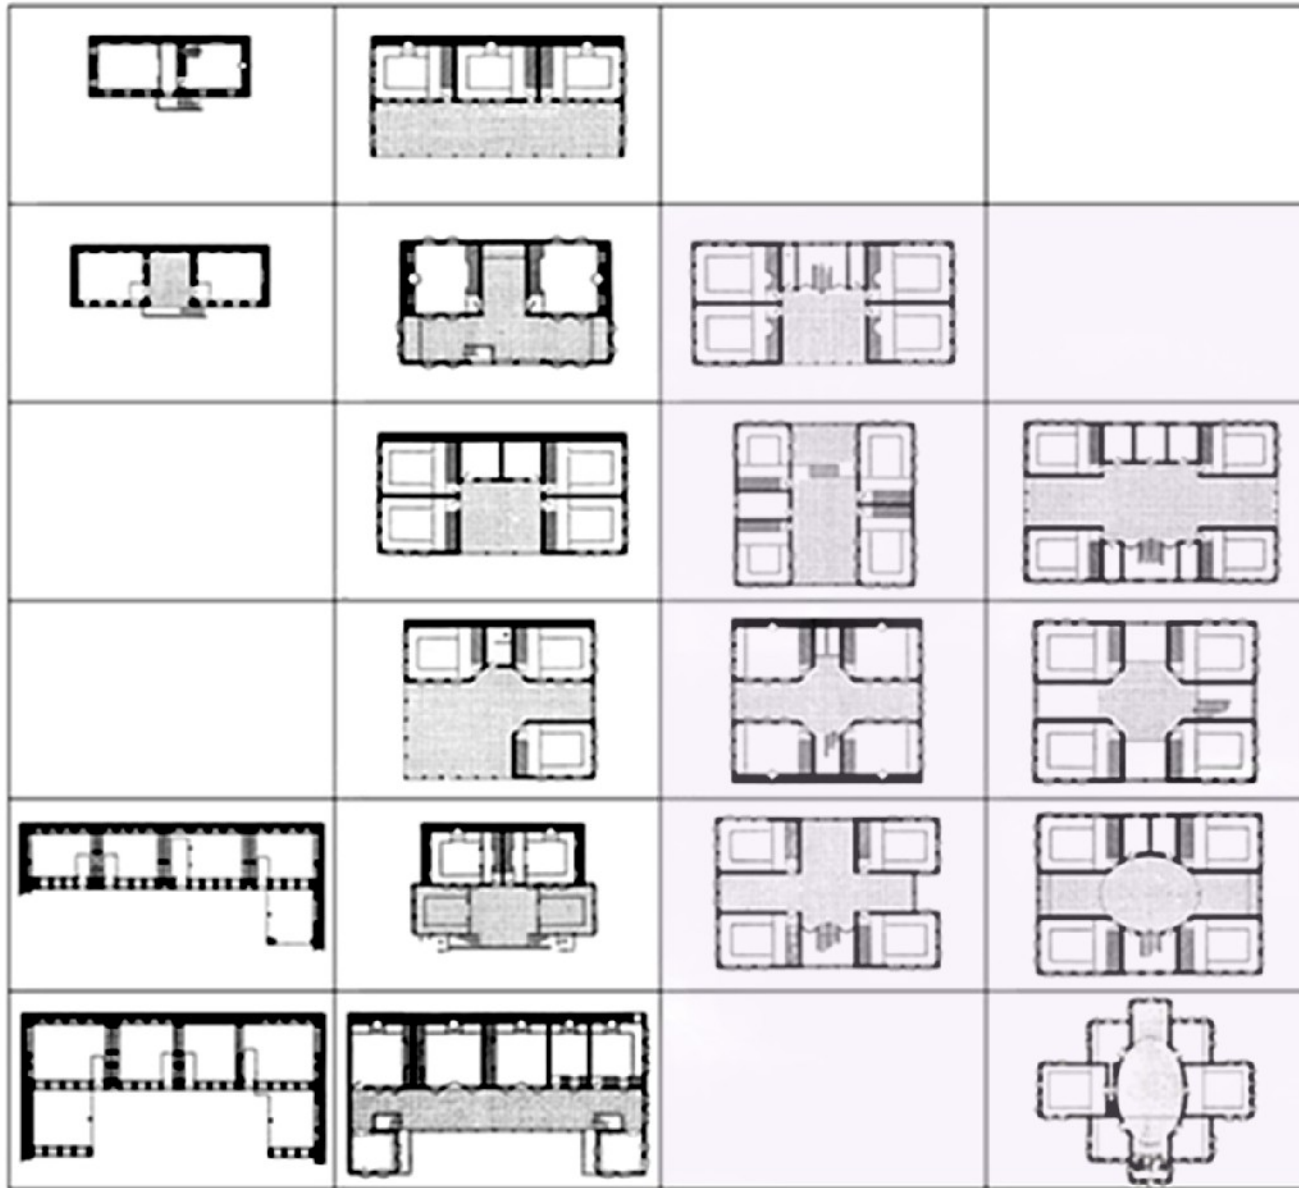
Without sofa

With outer sofa

With inner sofa

With central sofa

Plan types of various house samples

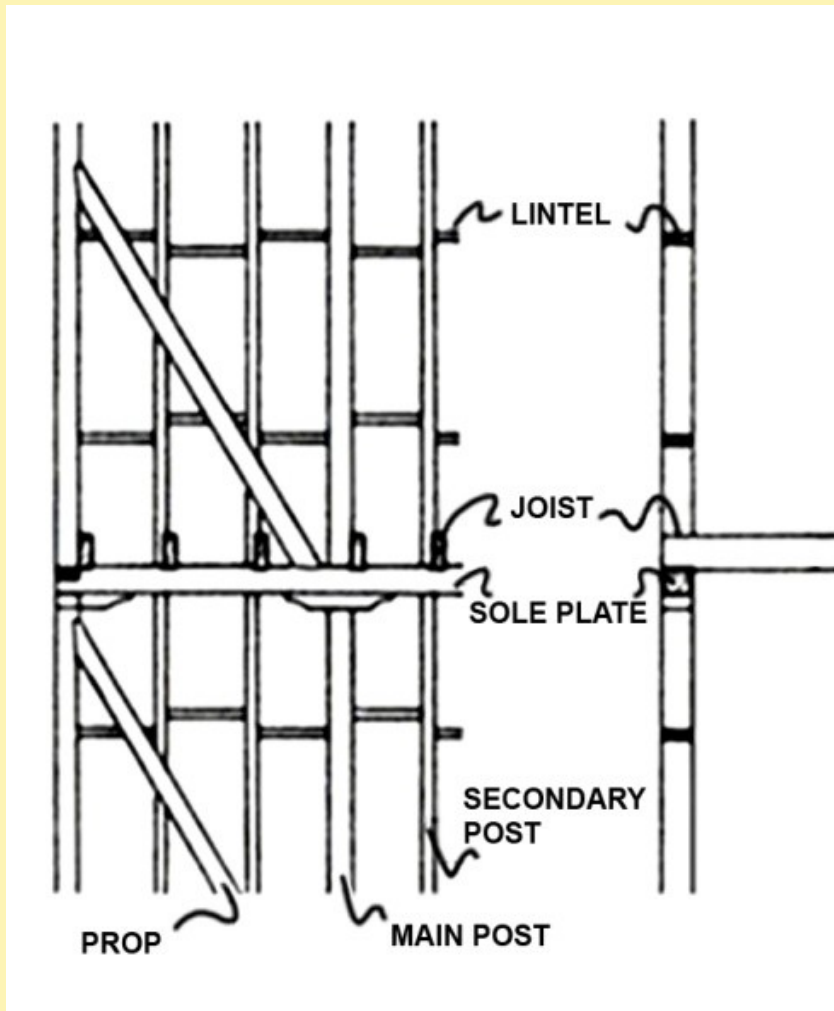
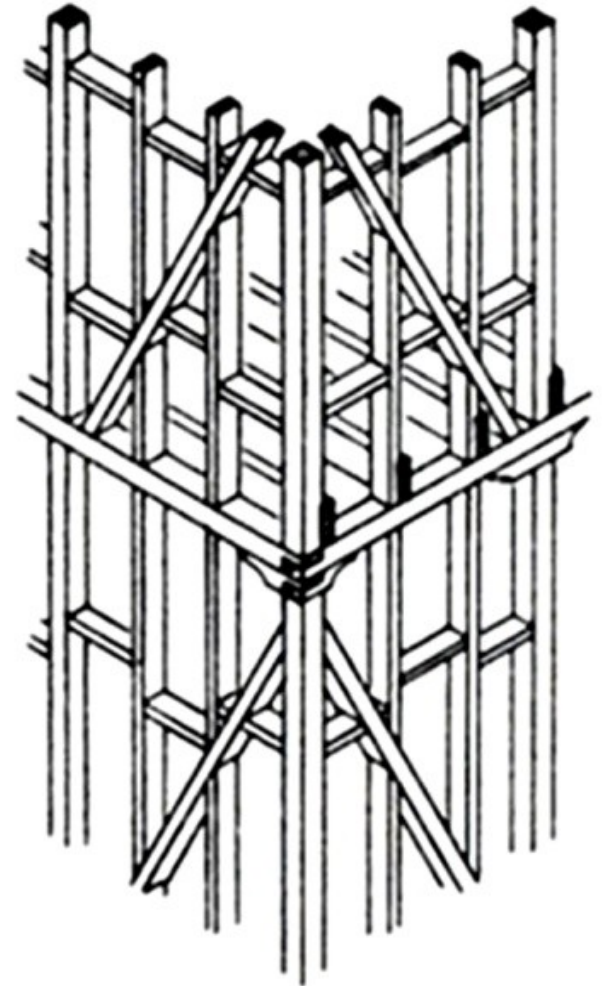
facade

perspective

Timber-framed structure with single sole on both sides' facade and perspective

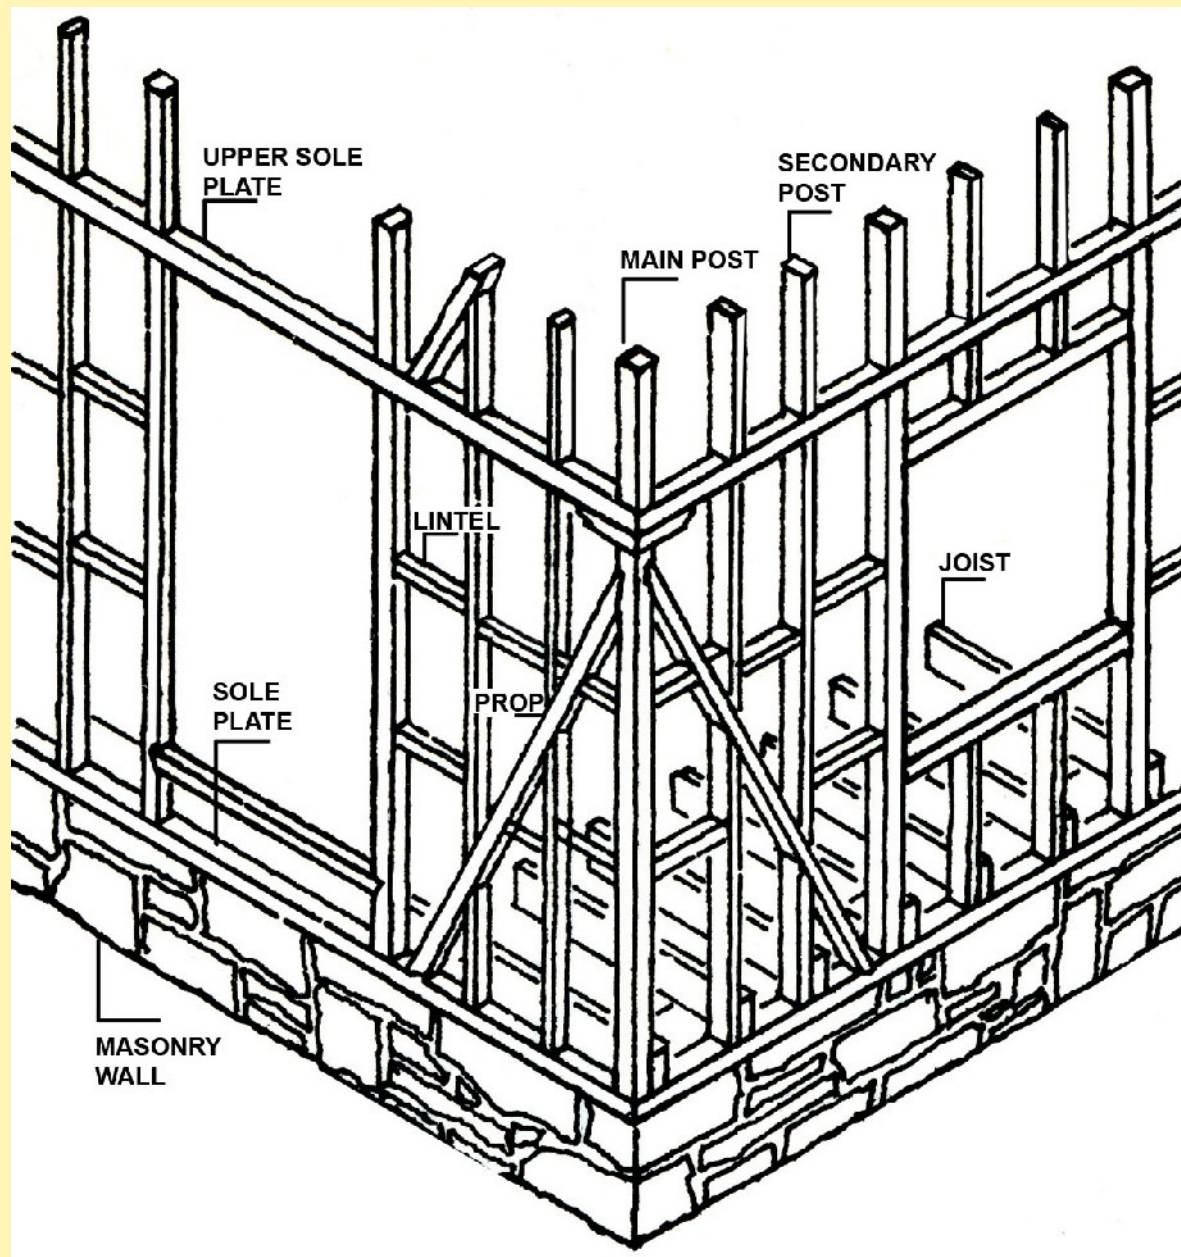
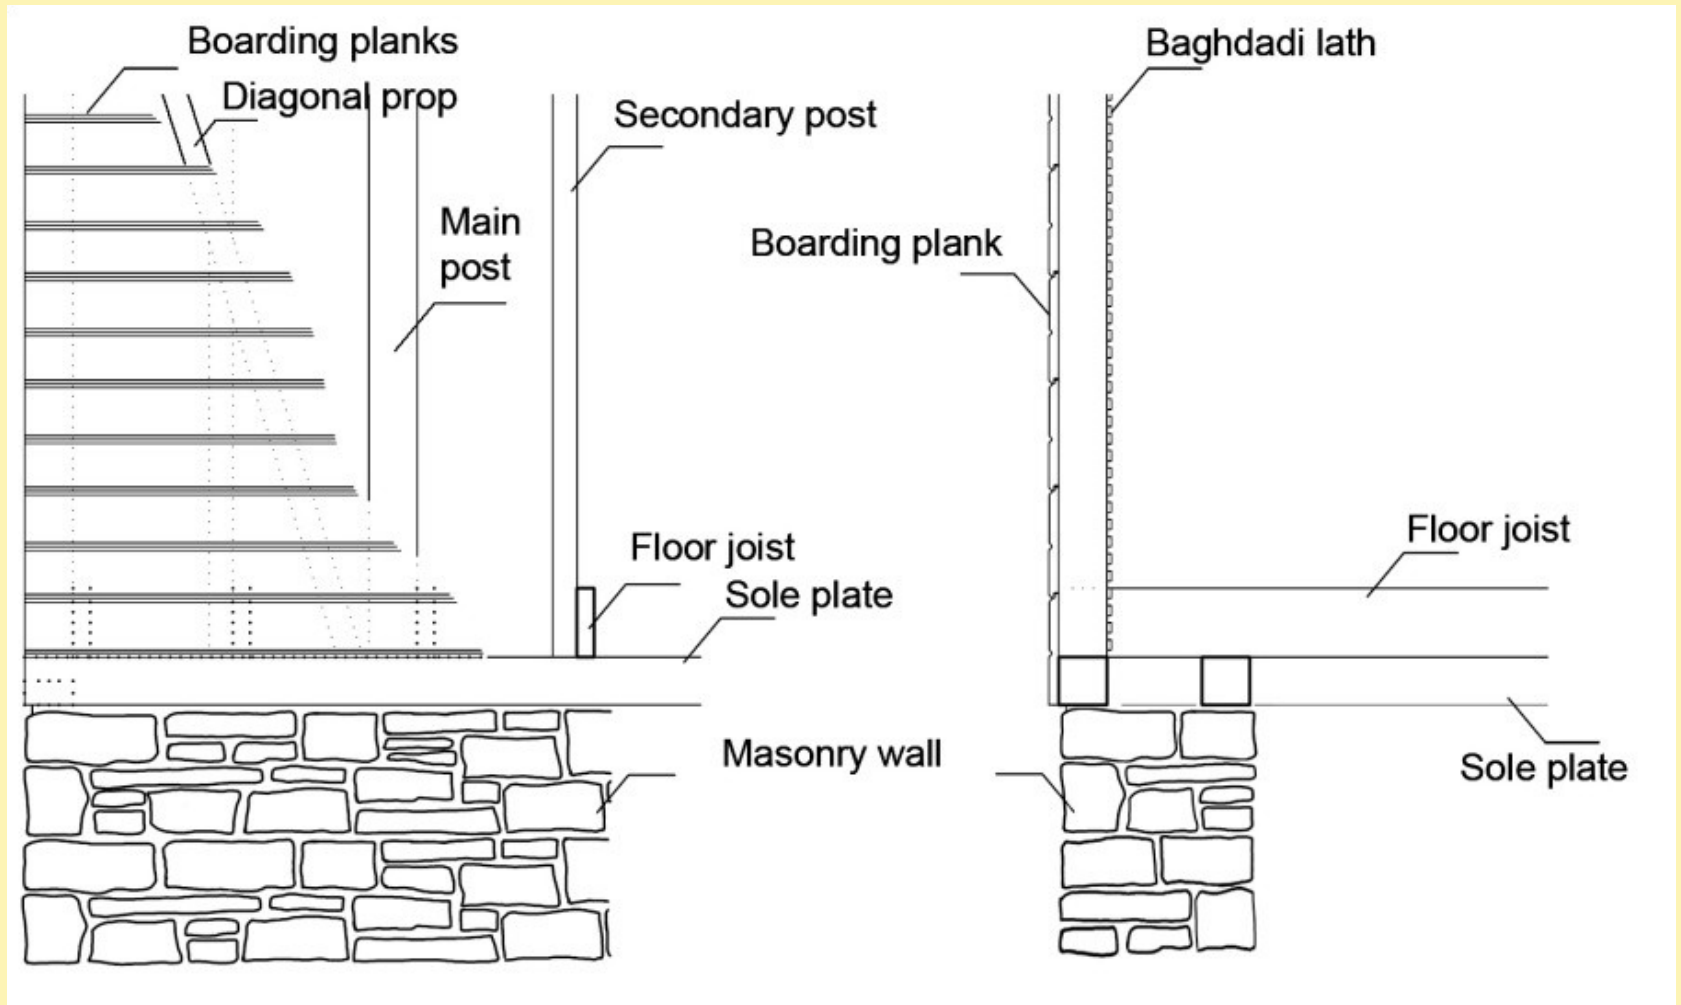
The unfilled timber frame system with boarding planks

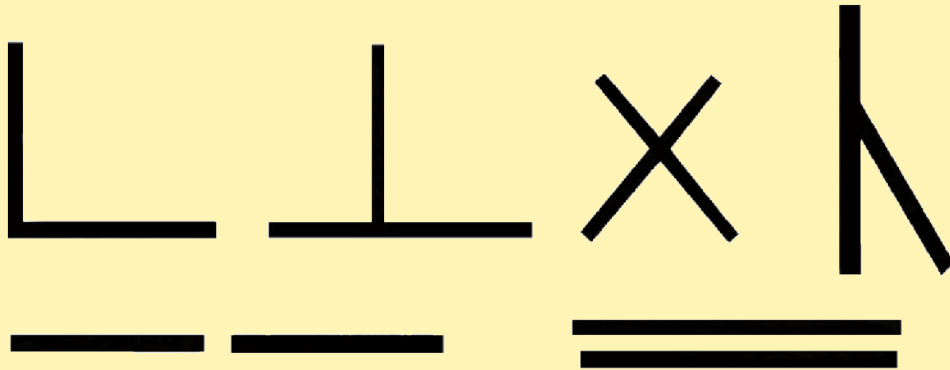
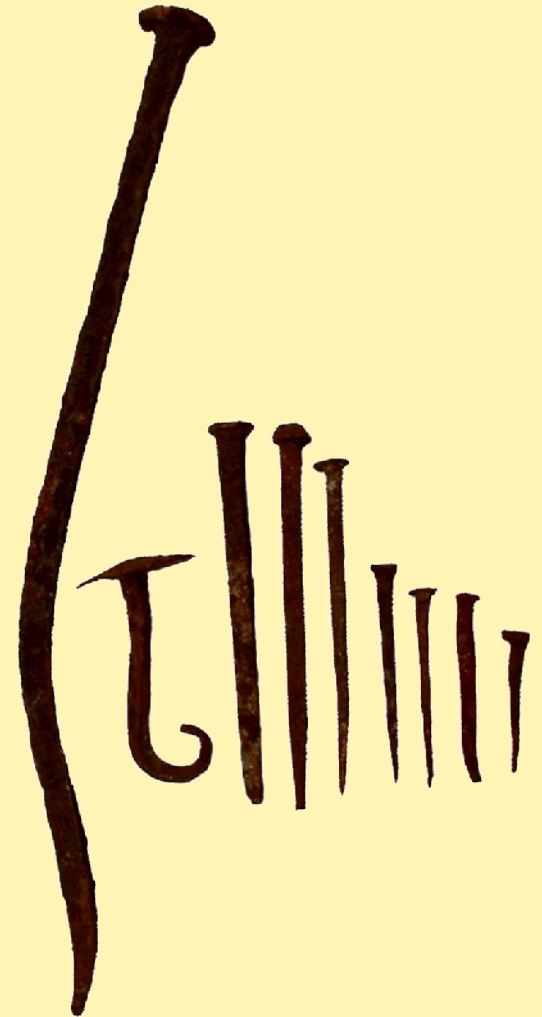
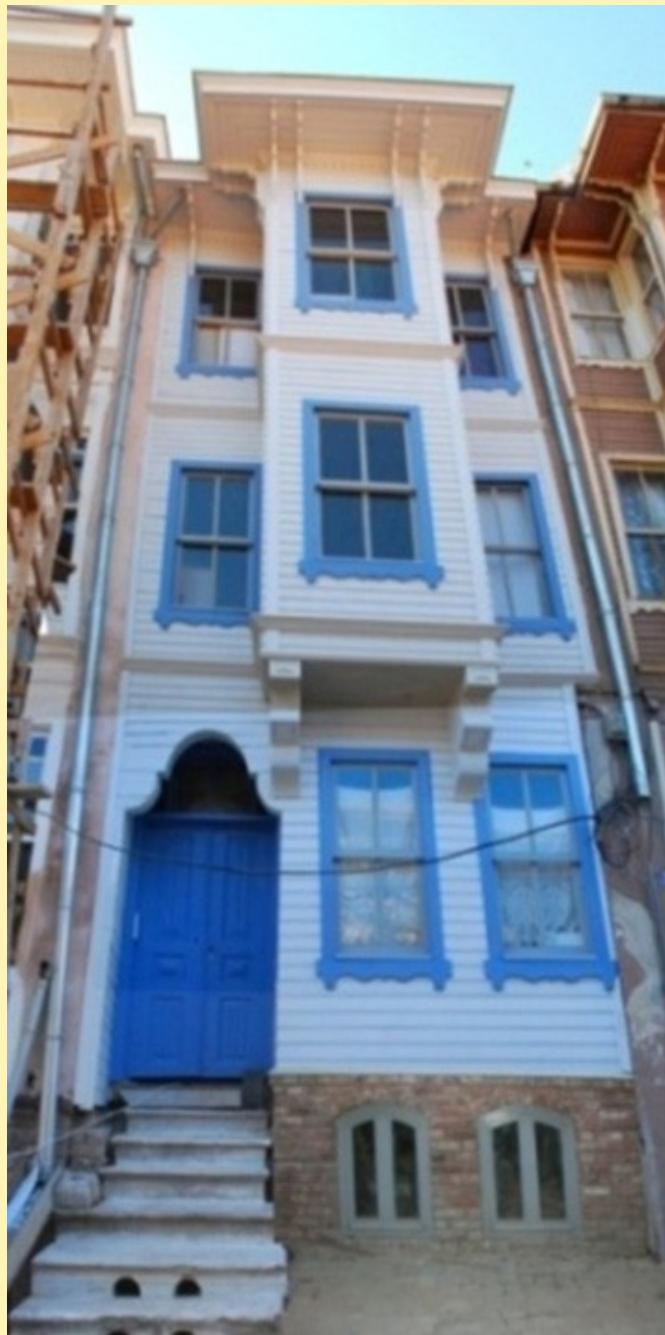
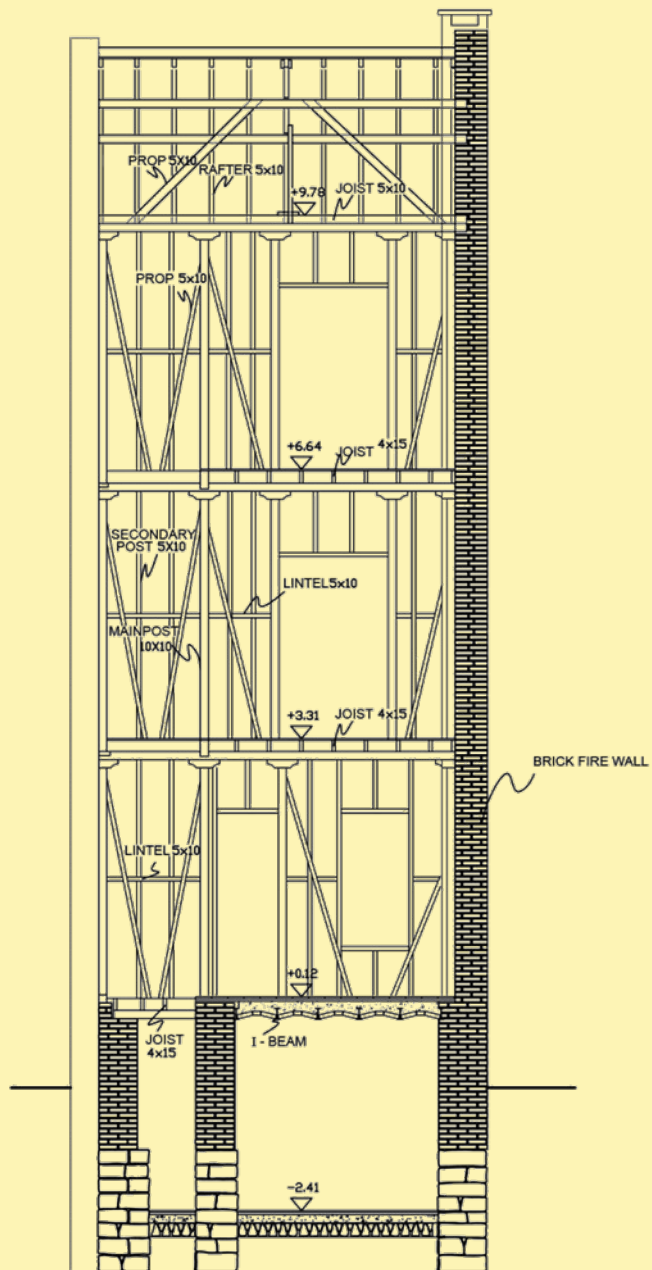
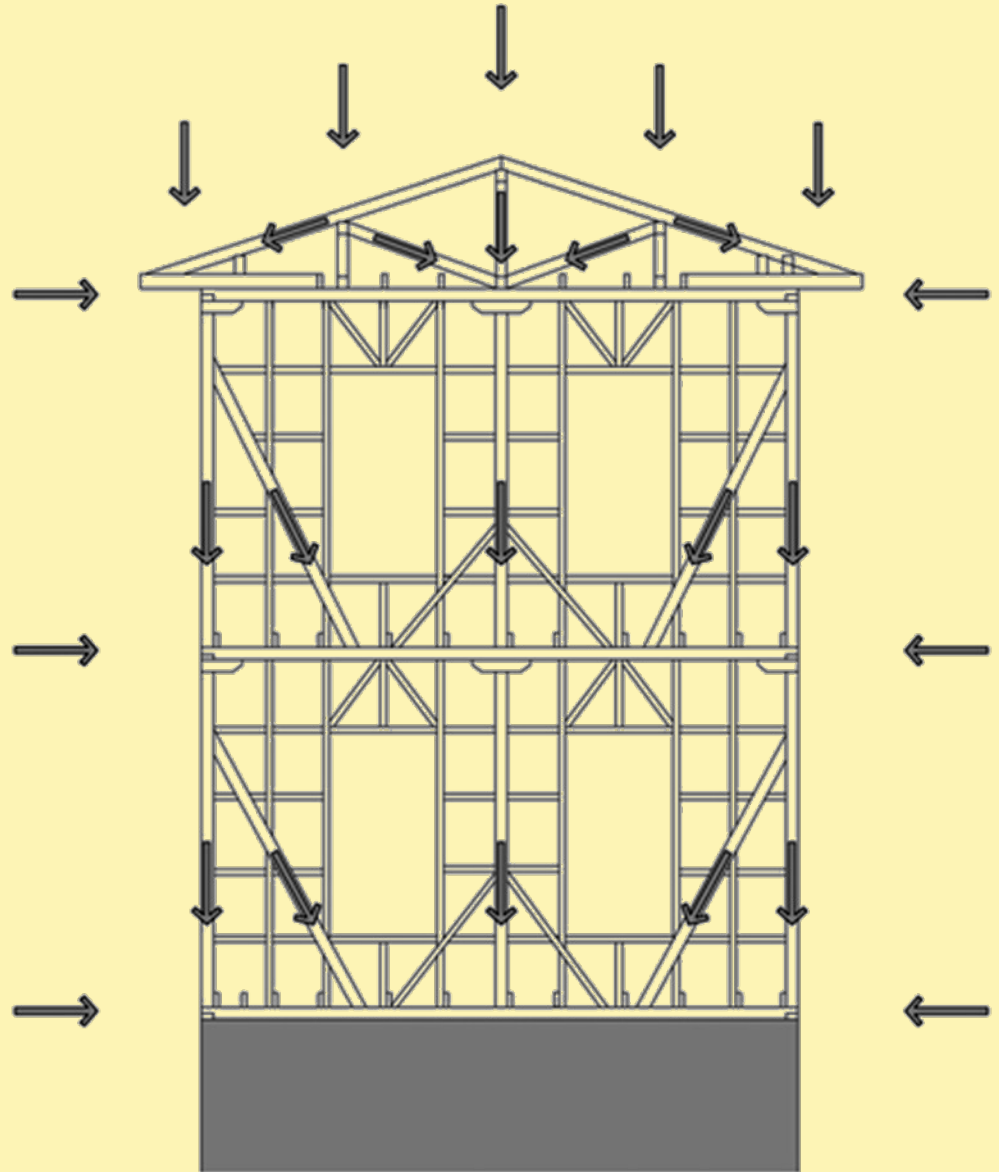
For node connection points used
wrought iron nails
